DEPARTMENT OF TRANSPORTATION**DIVISION OF ENGINEERING SERVICES**

Contract #: 04-0120F4Cty: SF/ALA Rte: 80 PM: 13.2/13.9File #: 69.28**WELDING INSPECTION REPORT****Resident Engineer:**Pursell, Gary**Address:** 333 Burma Road**City:** Oakland, CA 94607**Report No:** WIR-002352**Date Inspected:** 25-Apr-2008**Project Name:** SAS Superstructure**OSM Arrival Time:** 630**Prime Contractor:** American Bridge/Fluor Enterprises, a JV**OSM Departure Time:** 1530**Contractor:** Zhenhua Port Machinery Company, Ltd (ZPMC), Changxing Island **Location:** Shanghai, China**CWI Name:** Fu Yu Hong**CWI Present:** Yes No**Inspected CWI report:** Yes No N/A**Rod Oven in Use:** Yes No N/A**Electrode to specification:** Yes No N/A**Weld Procedures Followed:** Yes No N/A**Qualified Welders:** Yes No N/A**Verified Joint Fit-up:** Yes No N/A**Approved Drawings:** Yes No N/A**Approved WPS:** Yes No N/A**Delayed / Cancelled:** Yes No N/A**Bridge No:** 34-0006**Component:** OBG**Summary of Items Observed:**

The QA inspector witnessed ZPMC weld repairs at the junction of the U-ribs to the deck panels DP-017-002.

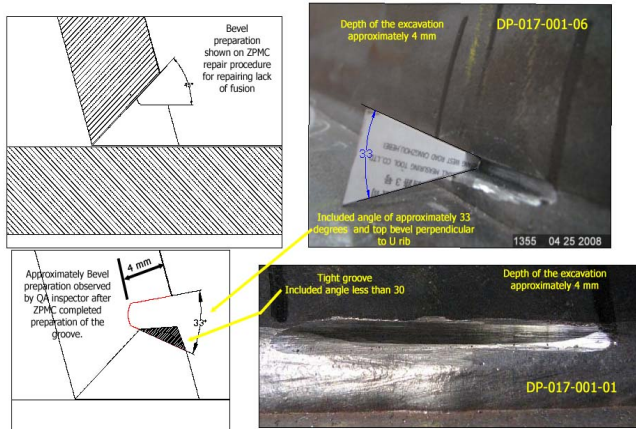
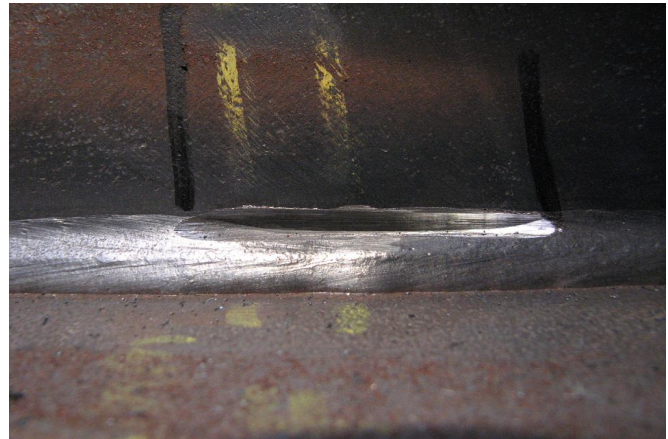
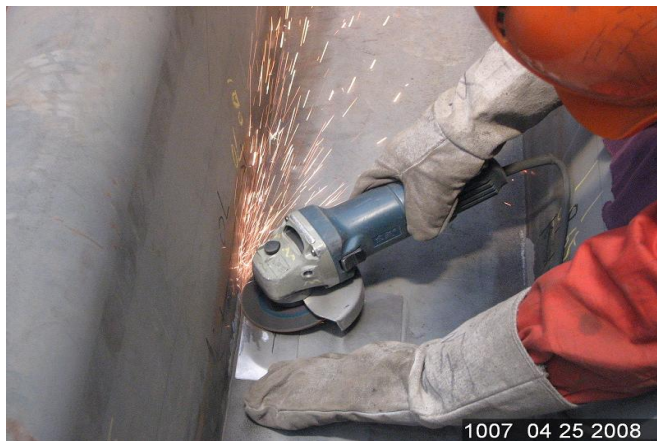
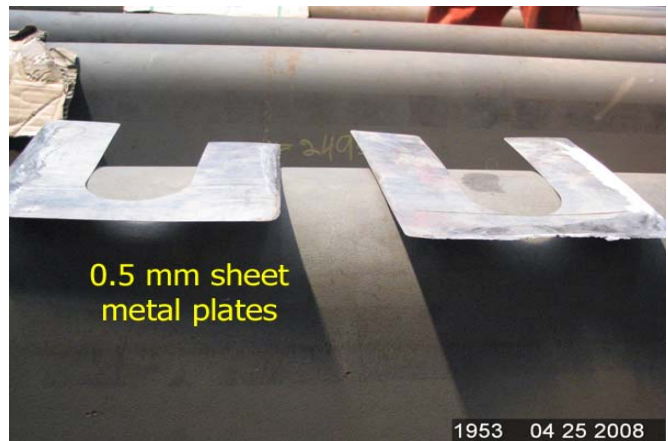
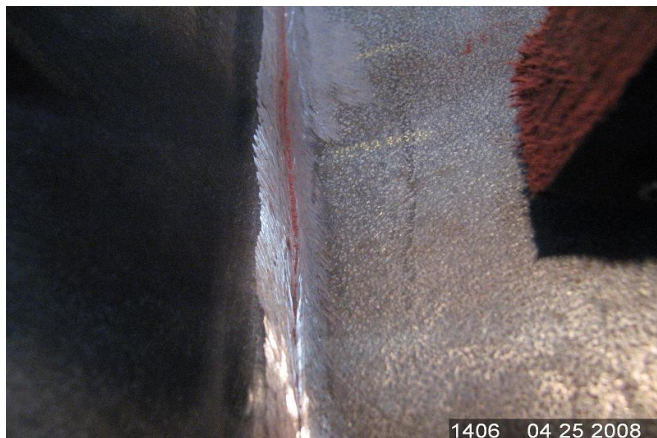
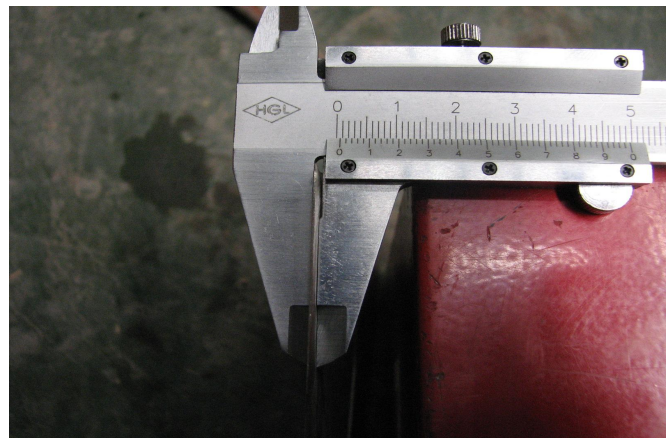
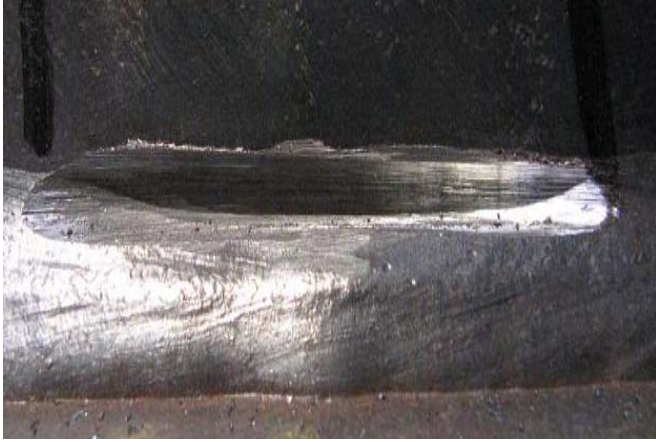
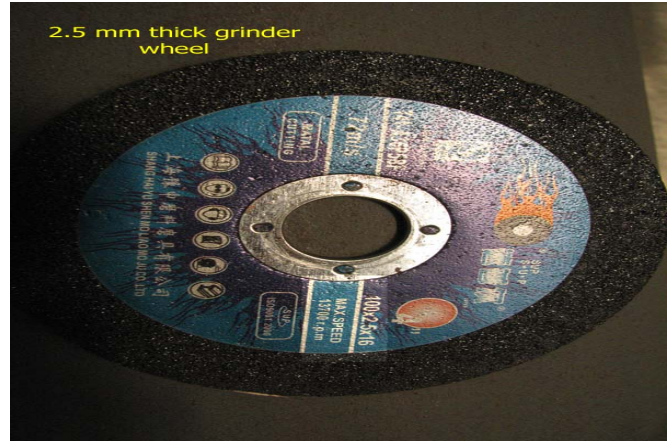
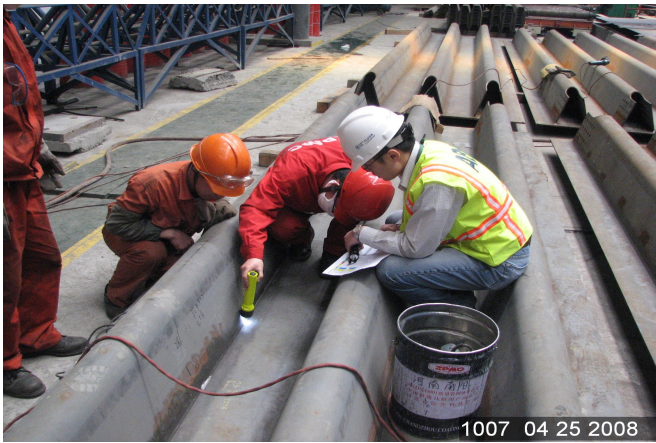
On this date the QA inspector observed that ZPMC was performing grinding operations with the 2.5 mm grinder wheel over a 0.5 sheet metal plate to avoid the removal of the base metal on the deck plate. The QA inspector had a conversation with the Task Leader Albert Carreon and Structures Material Representative Ady Velasco. The QA inspector informed the following observation:

1. ZPMC was not removing completely the weld overlap; a notch at the bottom toe was remaining after grinding operations. The QA inspector inspected with the straight rule using a light leakage technique and did not observe light leakage at the location inspected. However the QA inspector performed magnetic particle testing (MT) and observed questionable test (magnetic flux leakage) results from the notch condition from the remaining corner at the toe of the weld from the weld overlap.

2. ZPMC excavated the areas marked with lack of fusion and weld under fill with a 2.5 mm thick grinder wheel. The QA inspector observed that the groove preparation was not detailed on the repair procedure and because the tight groove profile was questionable if the welder could achieve that the width of the face of the weld could exceed the depth or width of the pass according to AWD 1.5 2002 Section 4.7.7. In addition the repairs were not being performed as detailed on the ZPMC's repair procedure. ZPMC's grinding operations on the lack fusion were

performed approximately perpendicular to the rib and not following the fusion line of the weld.

The photograph below shows ZPMC activities
